# Manhole Inspection Summary

Manhole # S06II2019MH

**Location** Address: **3406 SHELBURNE RD**

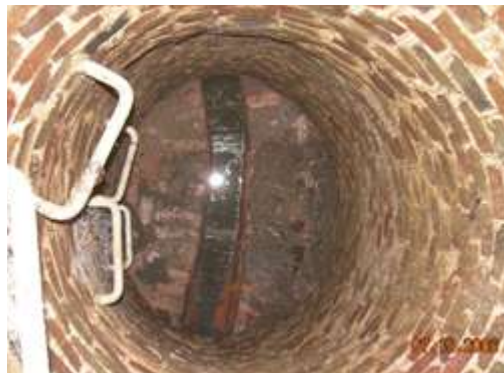
Top View

Corbel and Barrel infiltration. Evidence of surcharge - Bench debris.

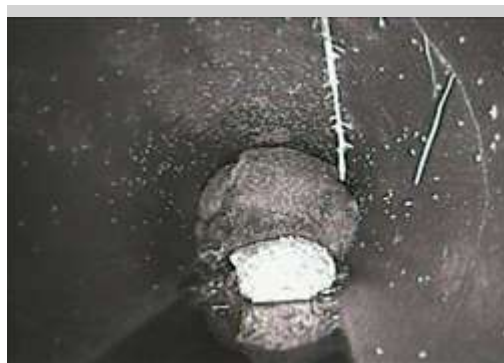
Inside of the I6

Clogged I6.

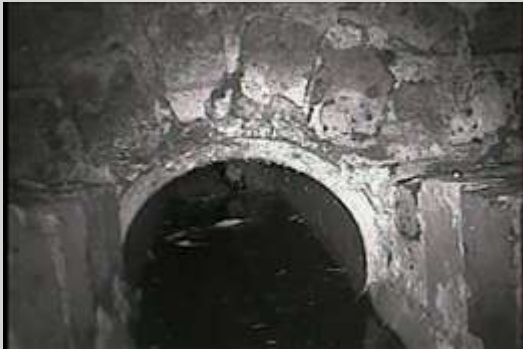
### 8 in. Circular Gravity Sewer Pipe Out @ 12 O'Clock

Invert Depth: **9.51** (ft.) Flow Characteristics: **Slow**

Infiltration: **Evidence** Pipe Seal Cond: **Cracked**

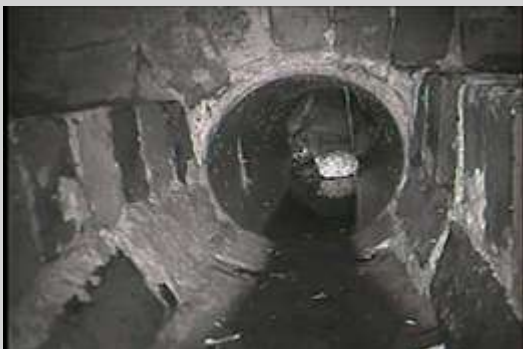
### 8 in. Circular Gravity Sewer Pipe In @ 6 O'Clock

Deposits: ☐ None ☐ Mud ☐ Sludge ☒ Debris ☒ Grease

Silt Depth: **6** (in.) Deposits Extent: **Heavy**

Infiltration: **Evidence** Pipe Seal Cond: **Unknown**
